KNOWLEDGE-BASED SUSTAINABLE DEVELOPMENT – CONTEMPORARY USE OF COMMUNIST-ERA URBAN DEVELOPMENTS IN THE CENTRES OF ROMANIAN CITIES

Horia Mihai Coman¹

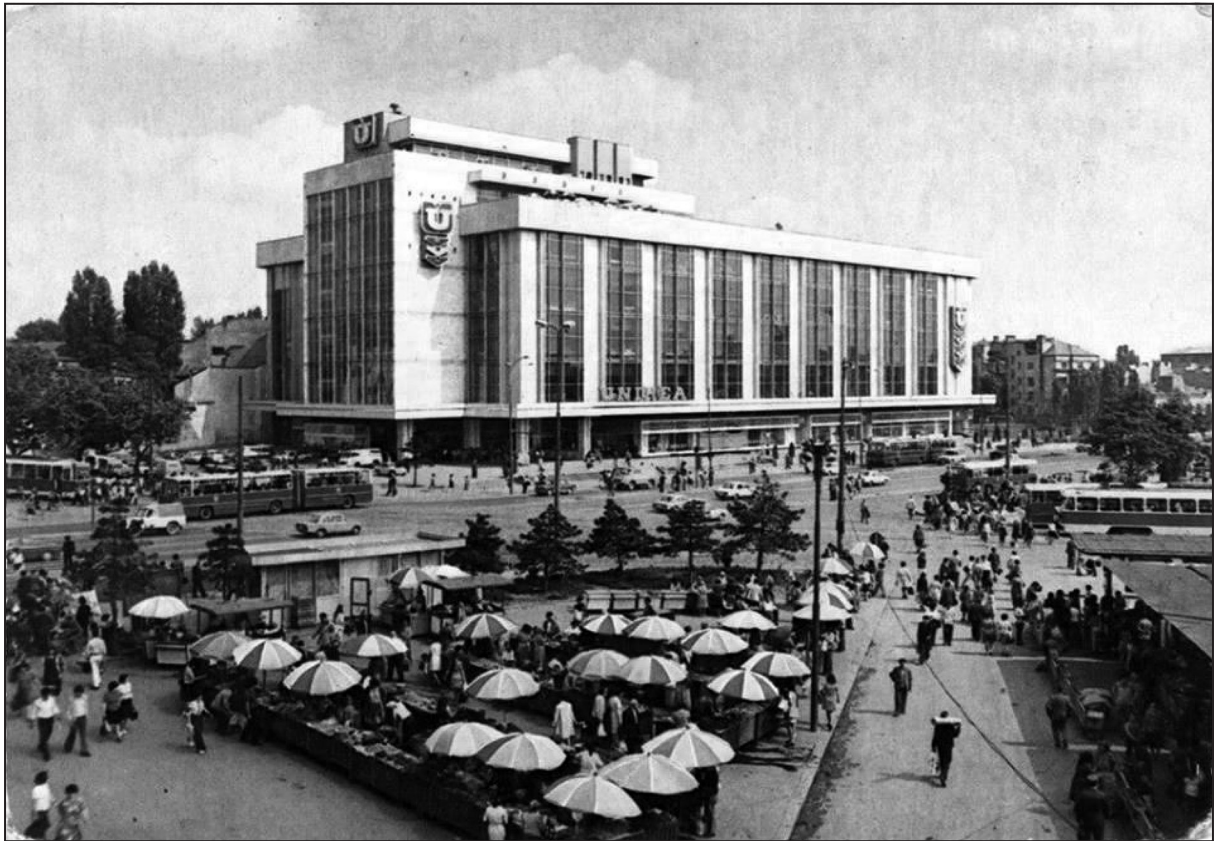
Figure 1: “Unirea” Universal Store, Bucharest: the first wing of the store, built 1976. It was to be later extended, with 2 adjoining wings, during the 1980s.

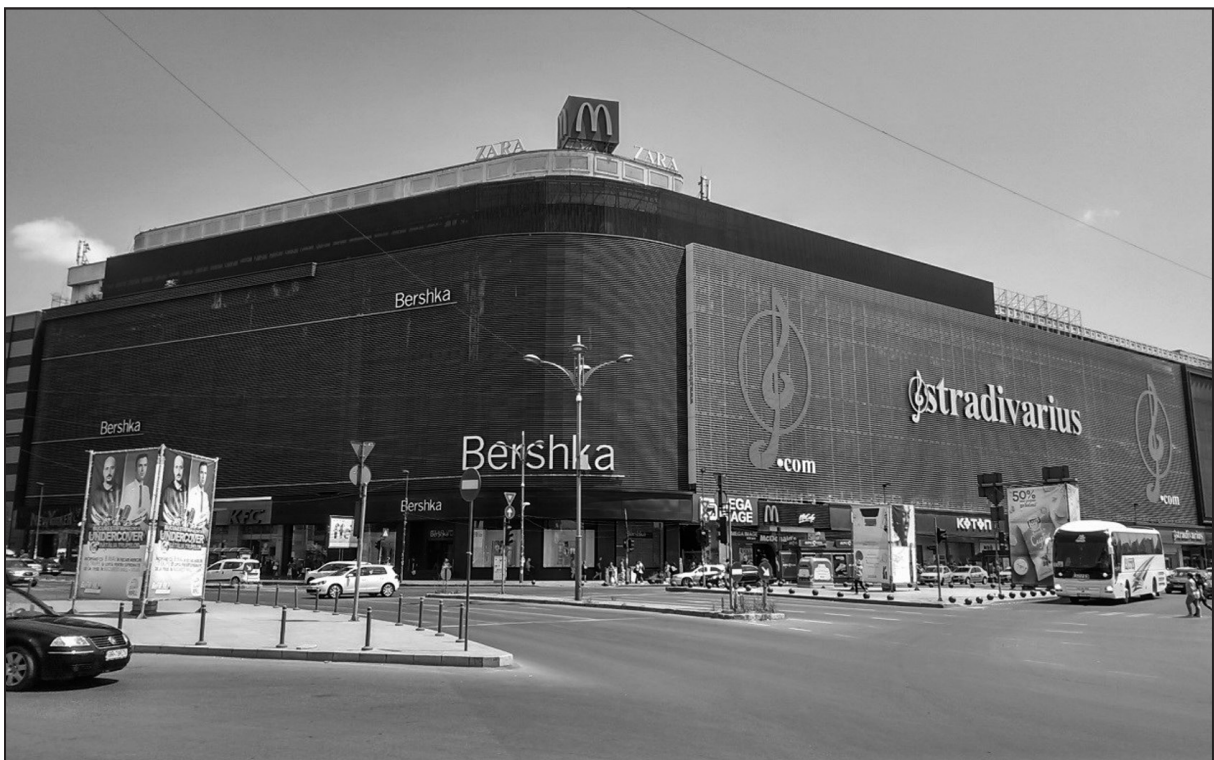
Figure 2: former “Unirea” Universal Store (Bucharest) in its current form, renamed “Unirea Shopping Center”. The new facade is covering the original one. There have been several changes in the appearance of the facade since the end of the socialist-communist era.

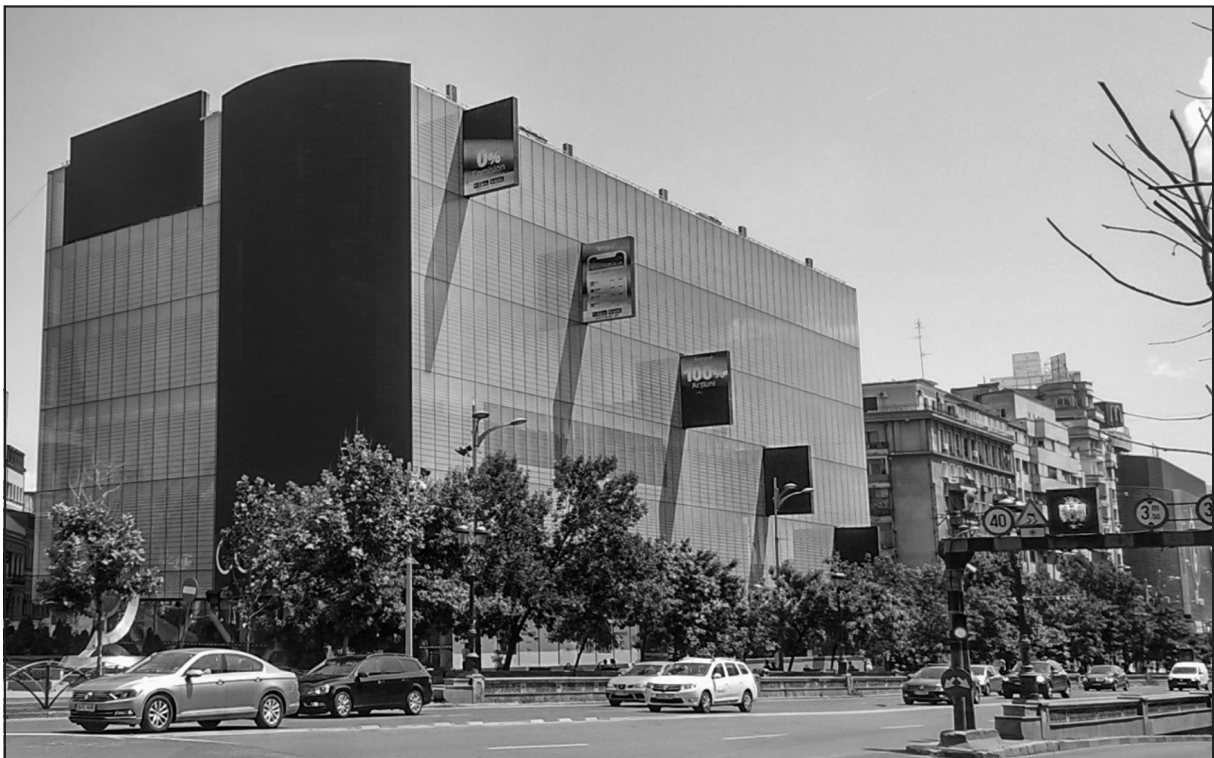
Figure 4: the “Cocor” store (Bucharest) in its current form, rebranded as luxury store and displaying multimedia facade. The picture is taken from the same approximate angle as the communist-era one.

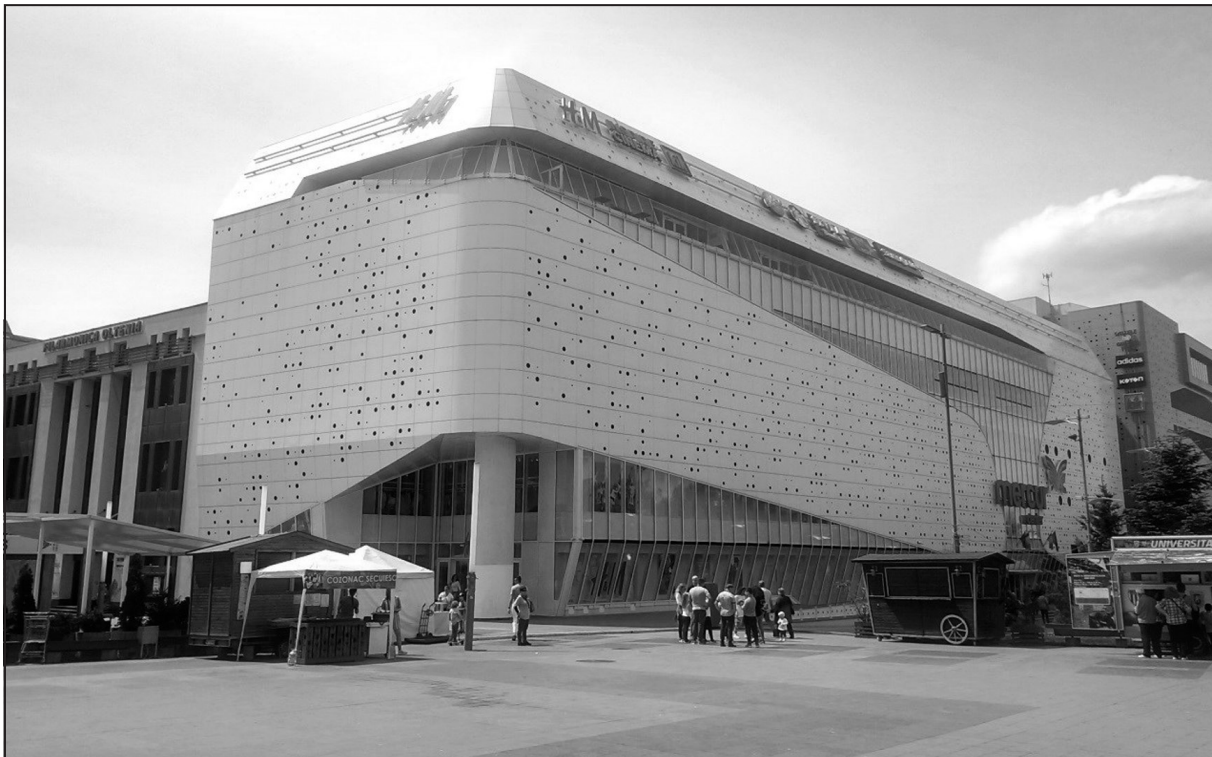
Figure 6: the new “Mercur” store (Craiova), consistently revamped (in 2015), renamed “Mercur Center”, and transformed into a mall (by today’s standards). The facade is strikingly modern, and has been largely acclaimed by the public.

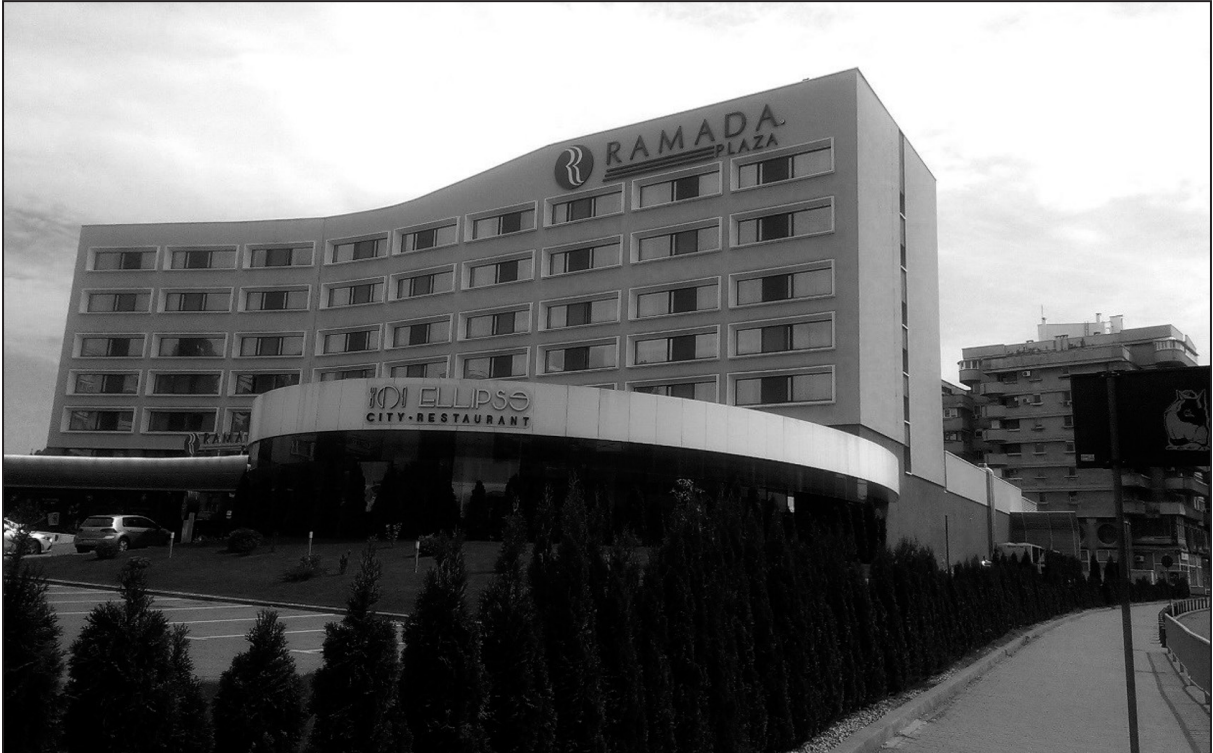
Figure 8: “Jiul” Hotel (Craiova) as today’s “Ramada Plaza”. The “Ramada” international hotel chain has recently bought the “Jiul”, revamping it with a couple of contemporary features, such as a new facade.

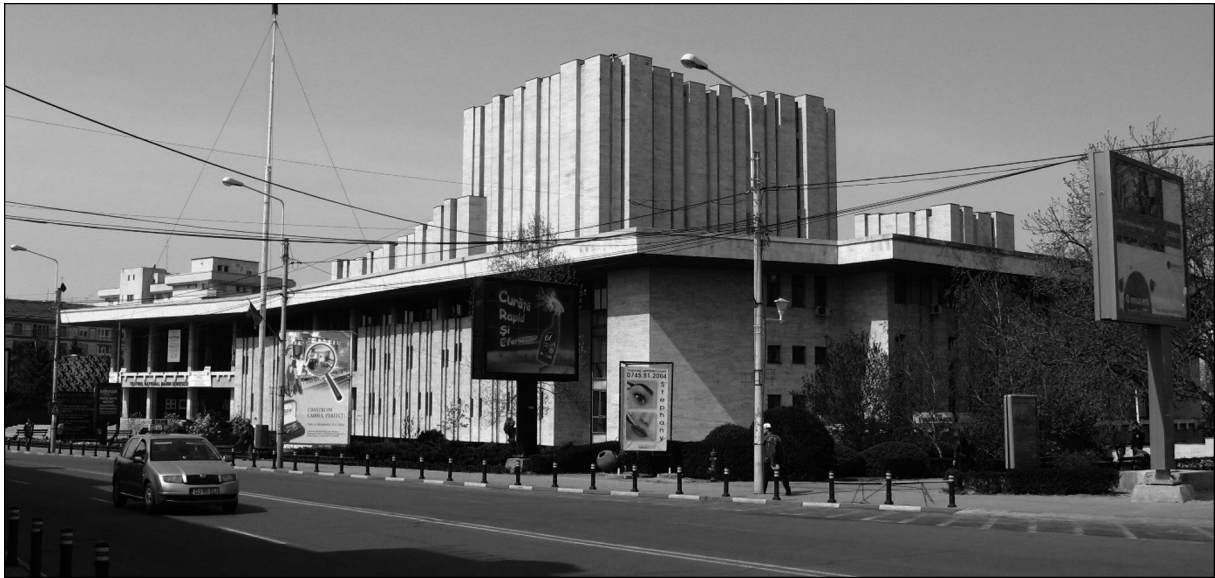
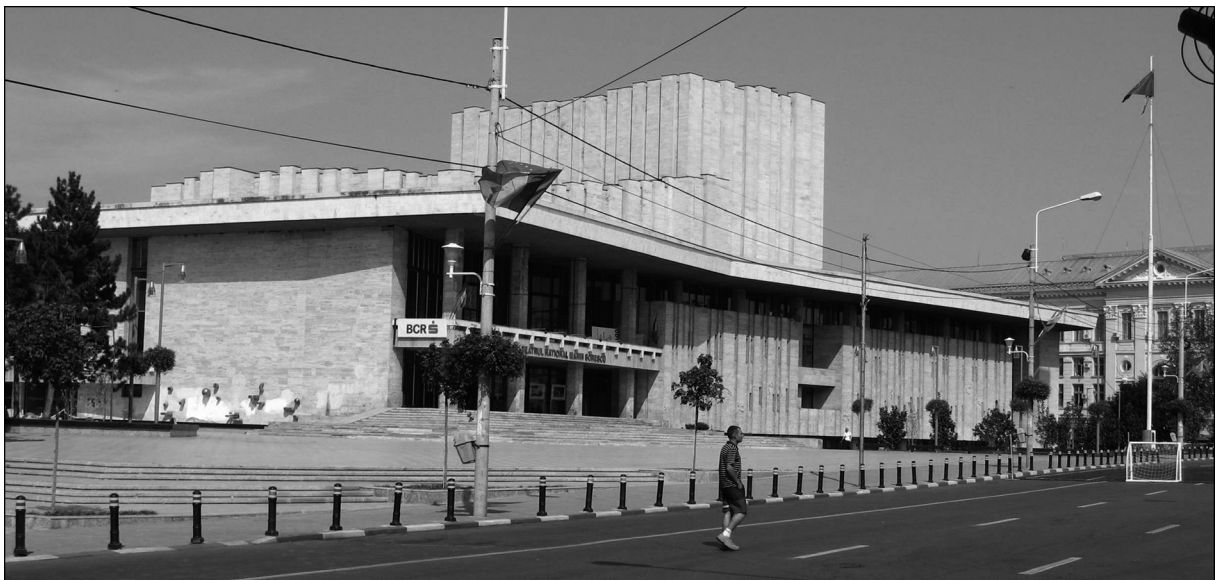
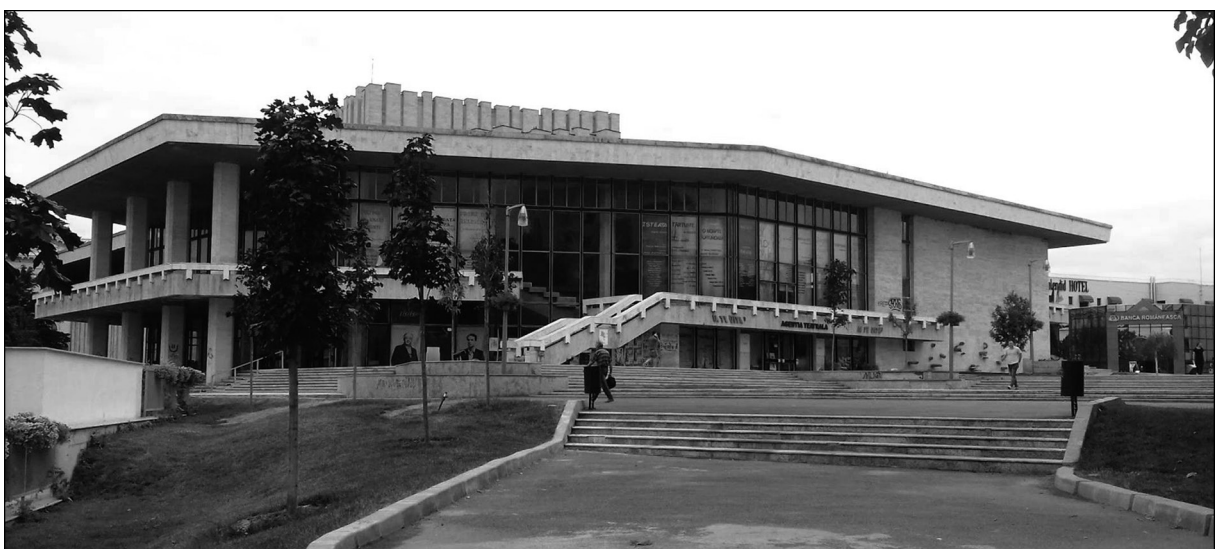
Figure 9, 10, 11: The National Theatre building, Craiova, erected 1969-1974 and displaying an unaltered, original facade. The area is very popular with the citizens of Craiova.

Therefore, cultural insight can also prove to be a useful tool in understanding the ways in which urban developments from the socialist-communist period are being used and edited today. For example, the building of the National Theatre of Craiova (a communist-era building that was designed and erected between 1969 and 1974) [4] is often perceived as a cultural value, having succeeded in earning an unusual status of “unofficial monument” in its “community” (the people of Craiova, here considered as a “collectivity”, from a sociological/anthropological point of view). Relatively new buildings and communist-era ones are rarely perceived as cultural values, and they are very rarely listed as protected heritage inside the Romanian law - thus turning the National Theatre building of Craiova into a special case.

Although it is not listed as heritage, so not technically a “monument”, the theatre building is often labelled as such by various citizens of Craiova and beyond, including some leading architects and intellectuals. The generally perceived - and often stated - architectural/cultural value of the building makes it an icon and (arguably) a symbol of the city, although Romanian law does not (yet) recognize it as such.

In return, this acclaimed cultural value of the Craiova theatre building may be considered as one of the reasons for which it has not been altered (in its original architectural design) following the fall of communism. The value of this particular theatre building largely rests on its perceived architectural qualities, mostly due to its special composition of volumes. This sets the Craiova theatre building apart from usual communist-era buildings – often labelled as dull, austere, common, severe, stern, etc. Therefore, in this chain of explanations, one can notice a “red wire” travelling between good architectural design, perceived cultural value, identity, conservation, and sustainability.

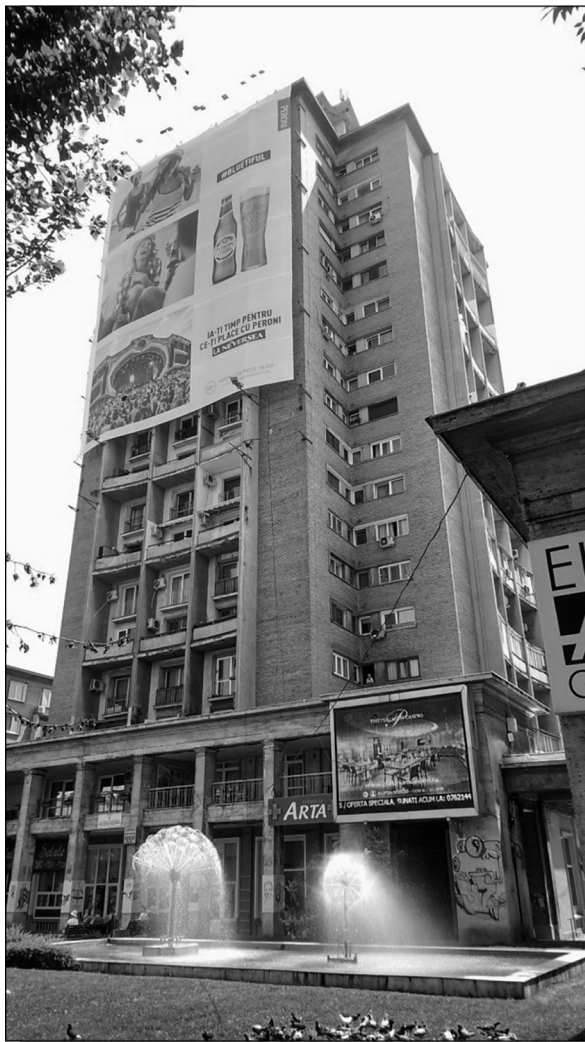
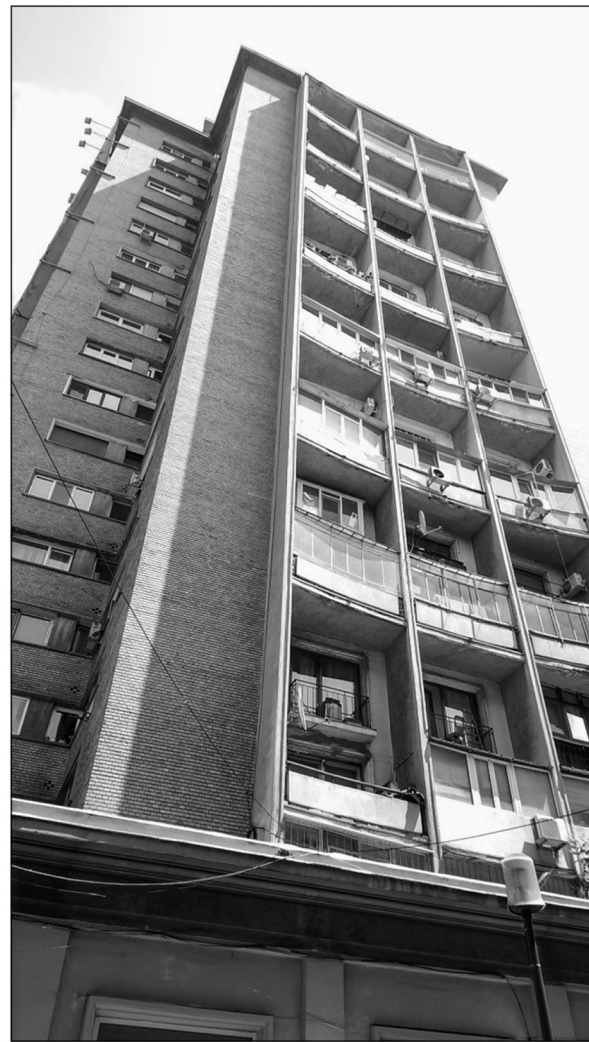
Figure 12, 13: “Gioconda” tower block, Bucharest, in 2 recent photos, showing very few marks of post-communist interventions. Built in 1959 as one of the highest apartment blocks in Bucharest up to that date, the building faces a high risk of collapse in case of a powerful earthquake. This is one of the reasons for which it has become a low-income block of flats, with apartment prices and rents being relatively low. Aside from a partial reinforcement of its load-bearing structure, the building has not been renovated/rehabilitated/revamped, as its seismic risk is jeopardising such potential investments, from a financial point of view. Some of the original windows and frames have been replaced by newer, more efficient ones. There are numerous cracks that can be seen on the facades. Some of the surfaces are cladded with travertine stone (an expensive material), but are badly upkept. Some surfaces are covered with graffiti. The advertising mesh is hindering the access of natural light inside the rooms that are behind it.

This is one of the reasons for which this particular group of buildings is facing considerable sustainability issues, as the risk of collapse affects it in many ways. For example, the “Gioconda” high-rise apartment block in Bucharest has become mostly unsustainable for renovation works and upkeeping. While other neighbouring apartment blocks - that pose a lower collapse risk - have been thermally rehabilitated and upgraded, the Gioconda tower is almost virtually “frozen in time” from when it was built, in the year 1959 [3]. The load-bearing structure of reinforced concrete has been consolidated only partially, as a complex system of causes and reasons have hindered the building’s security agenda. One of these drawbacks is the difficulty of sustaining the potential cost of a structural consolidation, as state contribution to the expenses is usually hard to obtain due to complicated and slow bureaucracy, widespread corruption and even lack of concern towards the matter. As the “Gioconda” is technically a condominium, with every

flat being owned by a private entity (usually residents), plus a few shops at ground level, a potential consolidation cannot be theoretically done if some of the owners refuse to contribute to the expenses. As some of the owners prefer not to invest money in the building's consolidation, the work cannot be done. Some of the residents are often caught in the situation of wanting to contribute, but not having the funds that are required, due to relatively low income. Because of this, public funding or sponsorships are usually sought after, but, as they rarely materialise, the owners of the flats prefer to stick to their properties, accepting the threat in case of a devastating earthquake.

Another potential solution to the problem theoretically exists, but its chances of success have also proven to be quite low. It's the practice of state-funded compensation for a private property that needs to be demolished because of various reasons. In this situation, the high risk of collapse can be easily considered as a risk to public safety, thus the structure can be designated to be demolished. In order for this to happen though, each private owner has to accept the offered compensation, and this is usually in the form of money or another flat in a new building, usually at the outskirts of the city. As the Gioconda block is in the core of Bucharest's city center, some owners refuse to move or accept the money from the state, as they don't consider the compensation to be fair, or to suit their needs and interests. In this situation, it is usually quite hard for the authorities to force the owners into accepting the compensations, if they refuse to...and this is due to the specific features of Romanian property law and urban development law, alongside the quite difficult and slow bureaucracy, plus the relatively low performance and amplitude of state-induced urban development.

For all these reasons, the "Gioconda" tower block has become a low-quality and low-income condominium. Many of the former residents have rented their apartments and moved into a probably safer flat/house. Some "original" residents, living in the tower block since it was built in 1959, have aged and have probably found it hard to move away. Because of its seismic risk, the Gioconda's flats are cheaper to sell/rent than similar flats in nearby blocks that have a lower seismic risk. This theoretically attracts more low-income owners and tenants to the Gioconda, making it quite unsustainable to afford proper structural rehabilitation. The facade has not been rehabilitated, some original pieces of cladding materials have fallen, and the building is in a quite bad shape, overall.

Another clue to its difficult situation is the frequent use of huge advertising meshes on the facade. These meshes are blocking window views from the flats to the outside, but the owners of the flats receive money for accepting advertising on their part of the facade. It is interesting to realise that the residents choose to renounce a considerable amount of daylight and urban view in order to receive some money from advertisers. Arguably, this phenomenon is more unlikely to happen on the facades of higher-income apartment buildings, but it's affecting a considerable amount of city-center apartment buildings similar to the Gioconda, where seismic risk is taking its toll on the quality of life of the residents, through the downfall of the prices of property. On the other hand, an aspect that cannot be overlooked is the fact that the tower block has adapted, and that it is now providing more accessible prices for apartments in the heart of Bucharest's city center...Some of the spaces are momentarily being used by some homeless people. The relatively bad shape of the facades may be considered to have attracted a few manifestations of street art, as some murals (plus some graffiti) have made their way onto the surfaces of the building. How sustainable is the Gioconda block actually? Yet again, the sustainability issue presents itself as a relative, debatable and problematic aspect.
